Draft Translation 753

THERMOGRAPHY CONTROL OF HEAT INSULATION AND TIGHTNESS OF BUILDINGS

. Axen and B. Pettersson

UNITED STATES ARMY
CORPS OF ENGINEERS
COLD REGIONS RESEARCH AND ENGINEERING LABORATORY
HANOVER, NEW HAMPSHIRE, U.S.A.

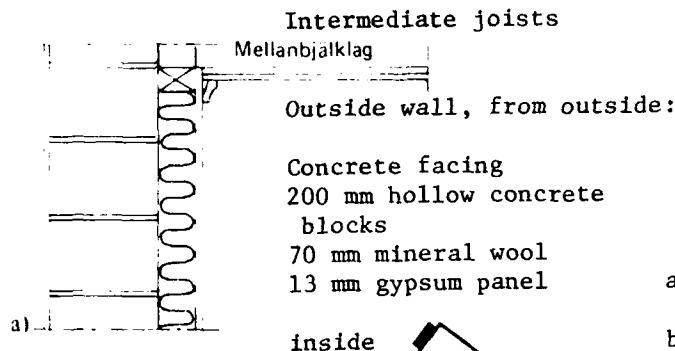
RELIABILITY OF MEASUREMENT METHOD - OUTSIDE WALL

FIGURE 37: Investigation of heat insulation capacity in surface portion of outside wall of hollow concrete blocks where a suspected deficiency has been verified by opening and visual inspection - bad fitting and filling of insulation material in the construction.

- Construction of outside wall.
- Wall portion opened from the inside. Insulation material consisted of smaller pieces insulation panel with unsatisfactory fitting in the areas between the studs. Inward air leak in the construction had caused dirt on the insulation material.
- Thermogram of partially cooled wall portion. The cooling is located at the vertical wall stud and the upper part of the wall.
- $t_{ref} = + 20^\circ\text{C}$
 $\Delta I = - 1.2$ isotherm units
 $\Delta t = 1.5^\circ\text{C}$
 $v = 0.5$ m/s (at the roof angle)

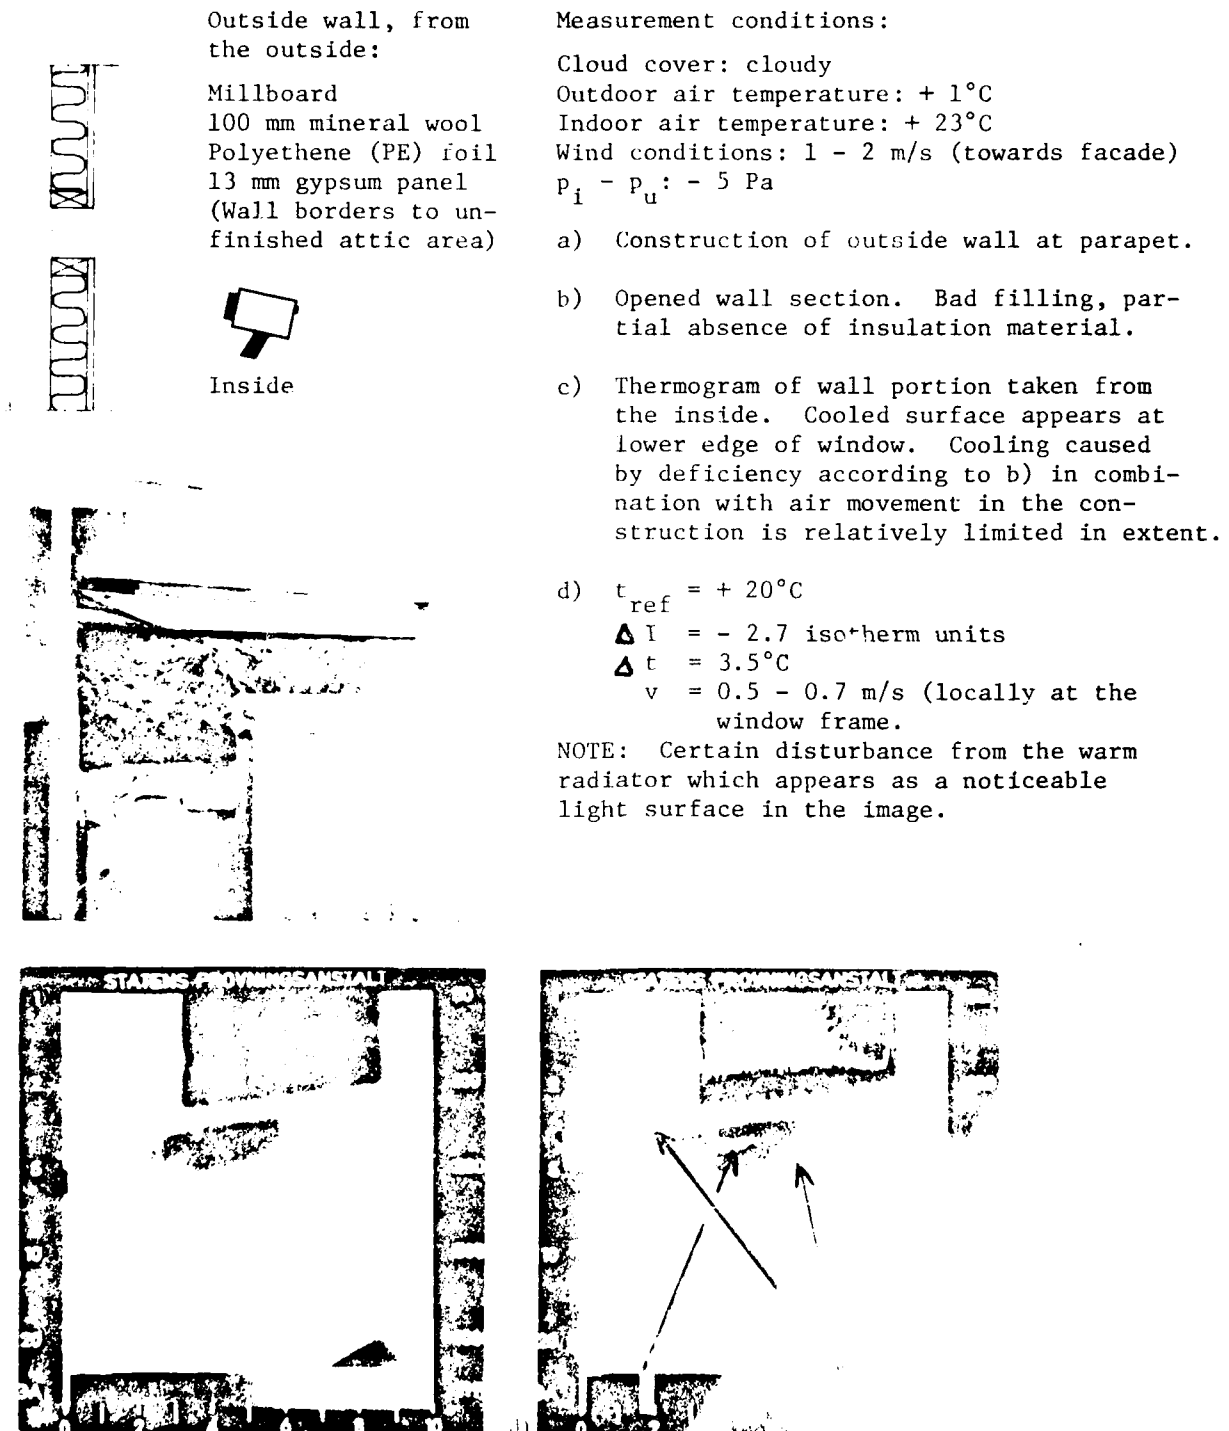
RELIABILITY OF MEASURING METHOD - OUTSIDE WALL

FIGURE 38: investigation of heat insulation capacity of outside wall portion where a suspected deficiency has been verified by opening the wall - bad filling with and partial absence of insulation material.

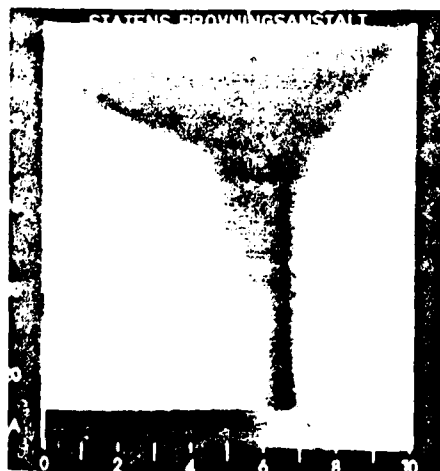
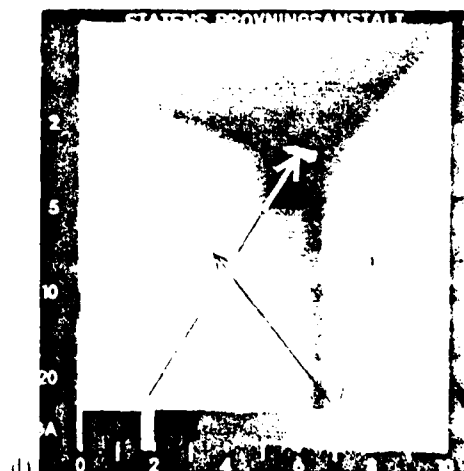
- a) Construction at the eaves.
- b) Observed deficiency (crack formation at the eaves).
- c) Thermogram of surface portion at the eaves showing a cooled area in the roof angle. The cooling is caused by inward air leakage through a joint (crack formation).
- d) $t_{\text{ref}} = +22^{\circ}\text{C}$
 $\Delta I = -5.3 \text{ isotherm units}$
 $\Delta t = 7.0^{\circ}\text{C}$
 $v = 1 - 3 \text{ m/s (locally at the roof angle)}$

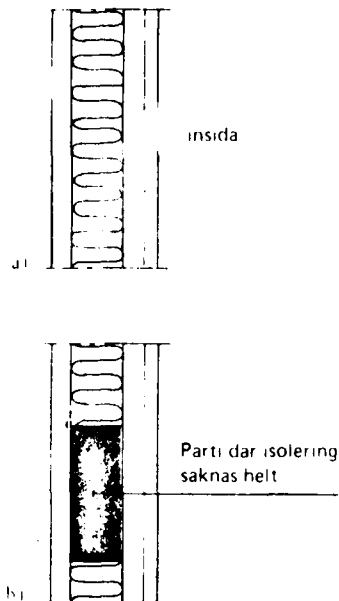
- a) Construction of outside wall with interior and exterior metal siding. (To the right in picture: Inside)
- b) Insulation missing for the entire thickness of some parts of the wall. (To the right in picture: Portion where insulation is totally absent).
- c) Thermogram of cooled surface portion in the middle of wall. The defect is related to total absence of insulation material in certain portions of the wall.
- d) $t_{ref} = + 11^{\circ}\text{C}$
 $\Delta I = - 1.0$ isotherm unit
 $\Delta t = 2.0^{\circ}\text{C}$
 $v = 0$ m/s

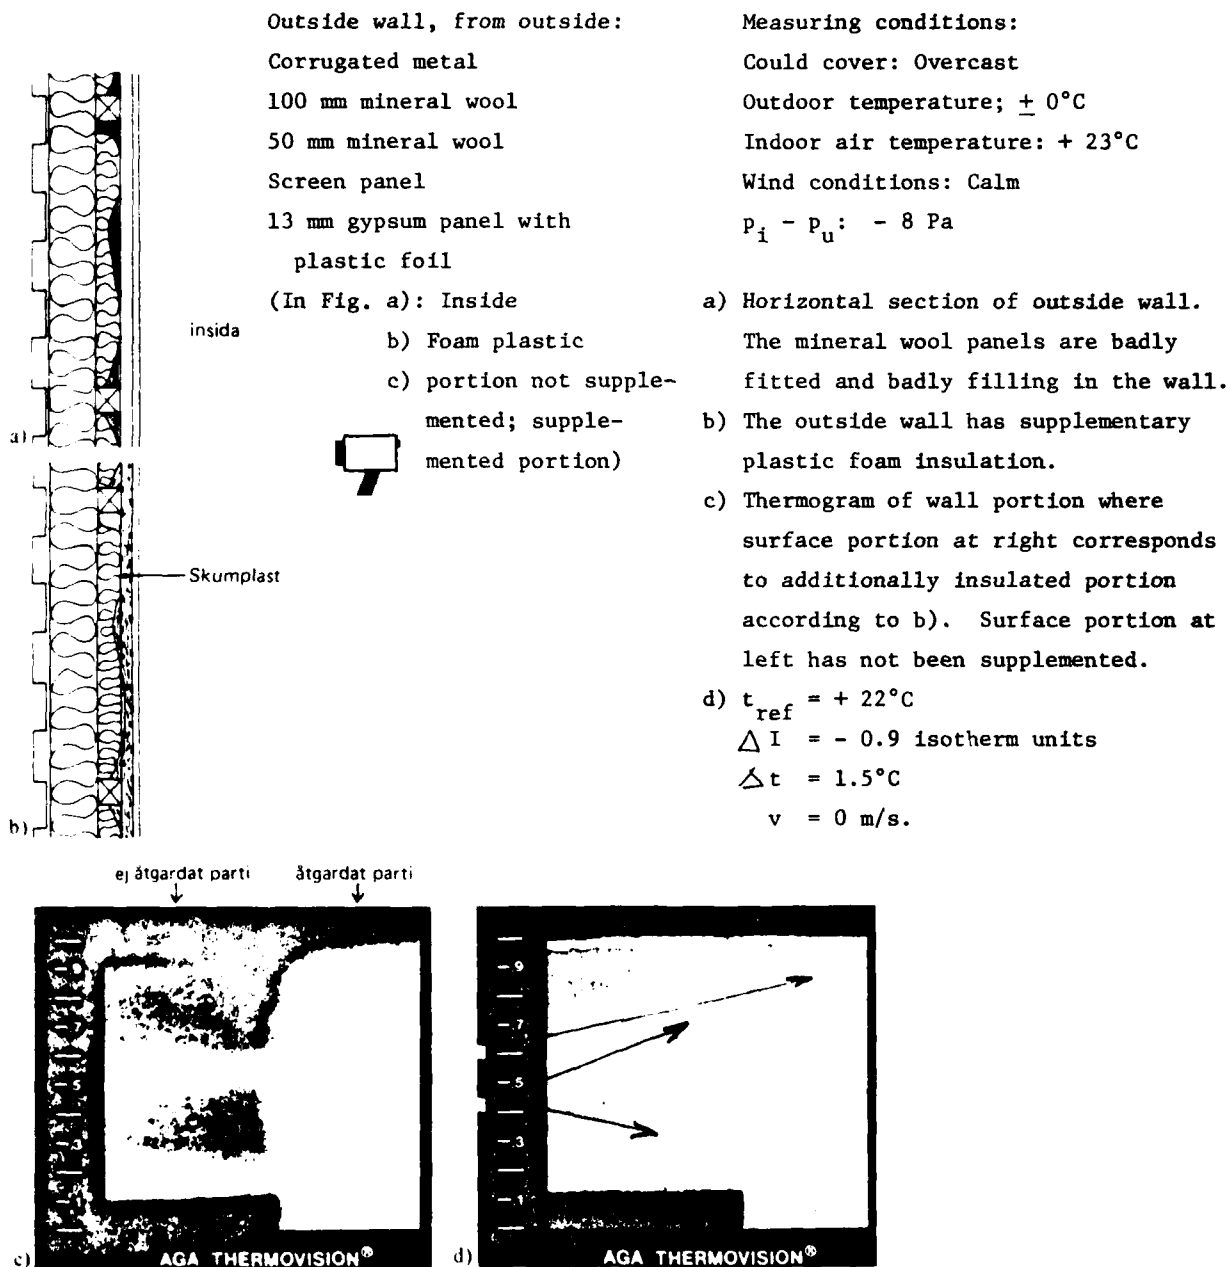
FIGURE 122: Supplementation of a certain part of wall portion by means of injecting plastic foam of carbamide resin type. Portion with supplementary insulation shows satisfactory insulation and tightness functions, while no change is noted in portion where action has not been taken.
